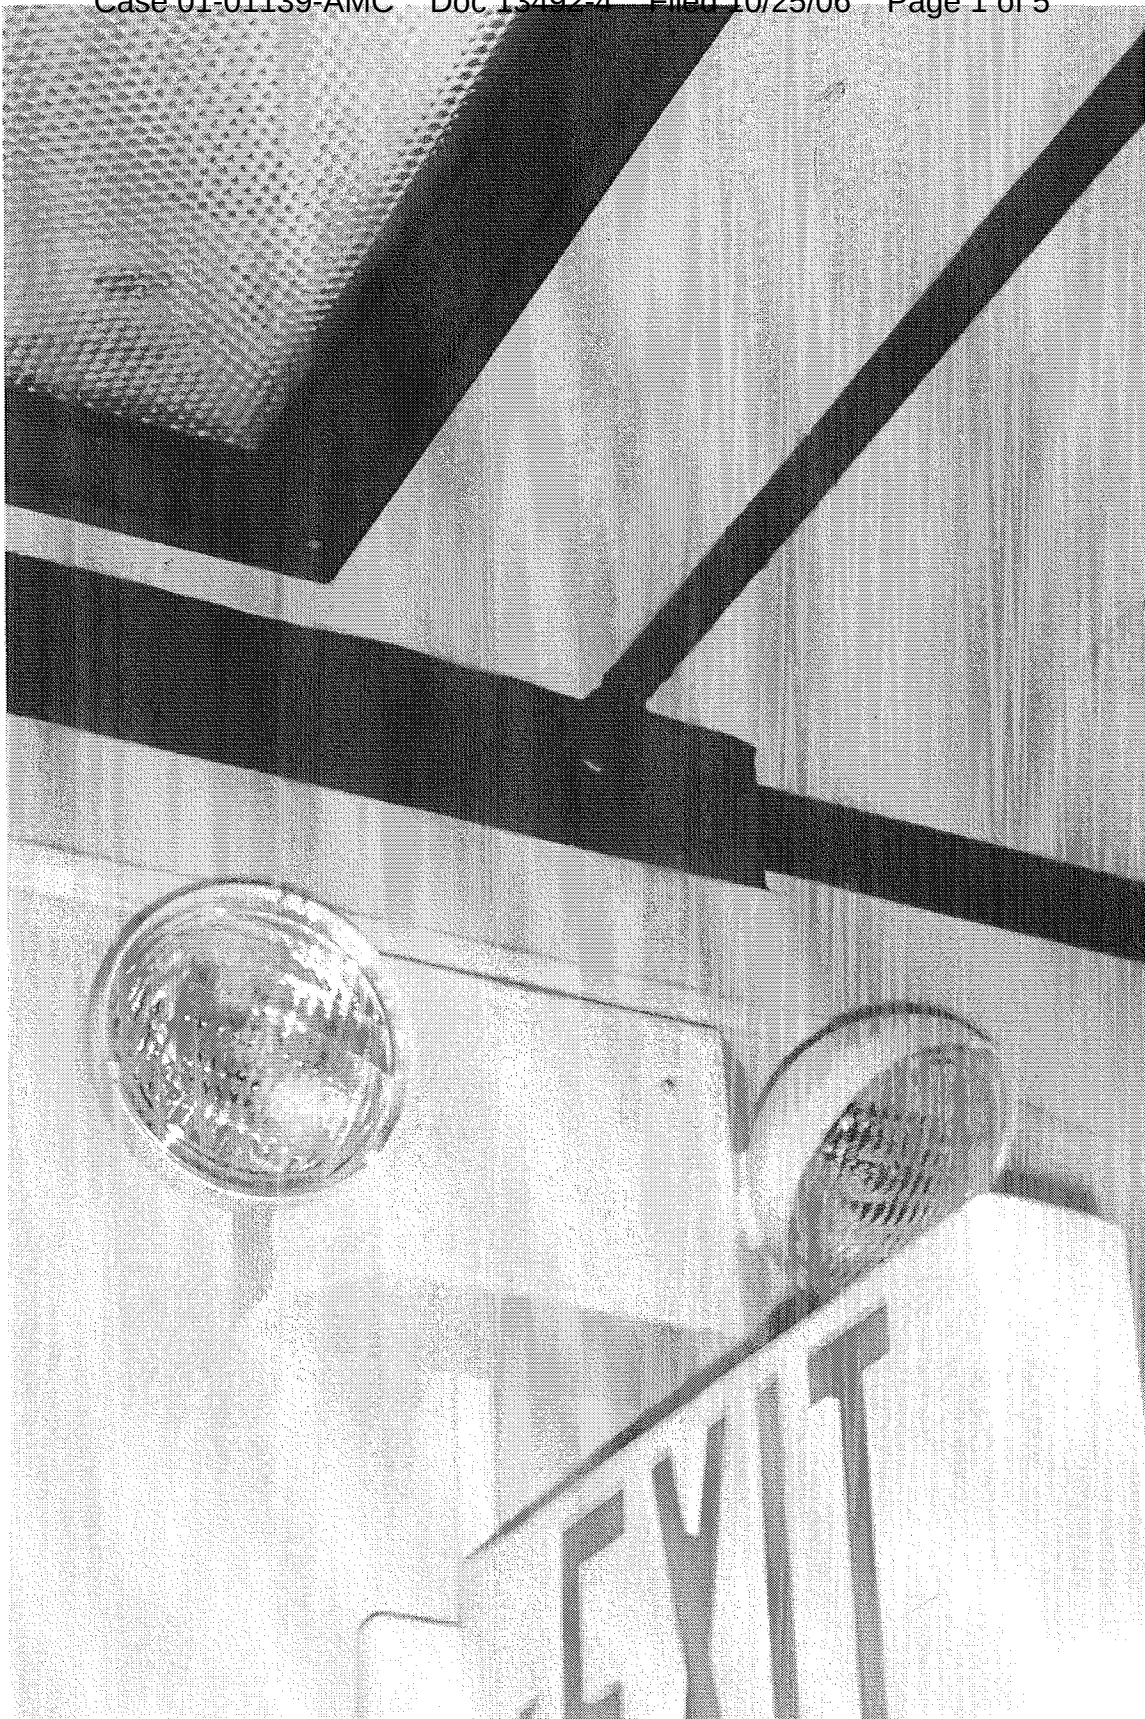
86. 3rd floor, west hall adj to lobby - acoustical plaster above emergency light in west office

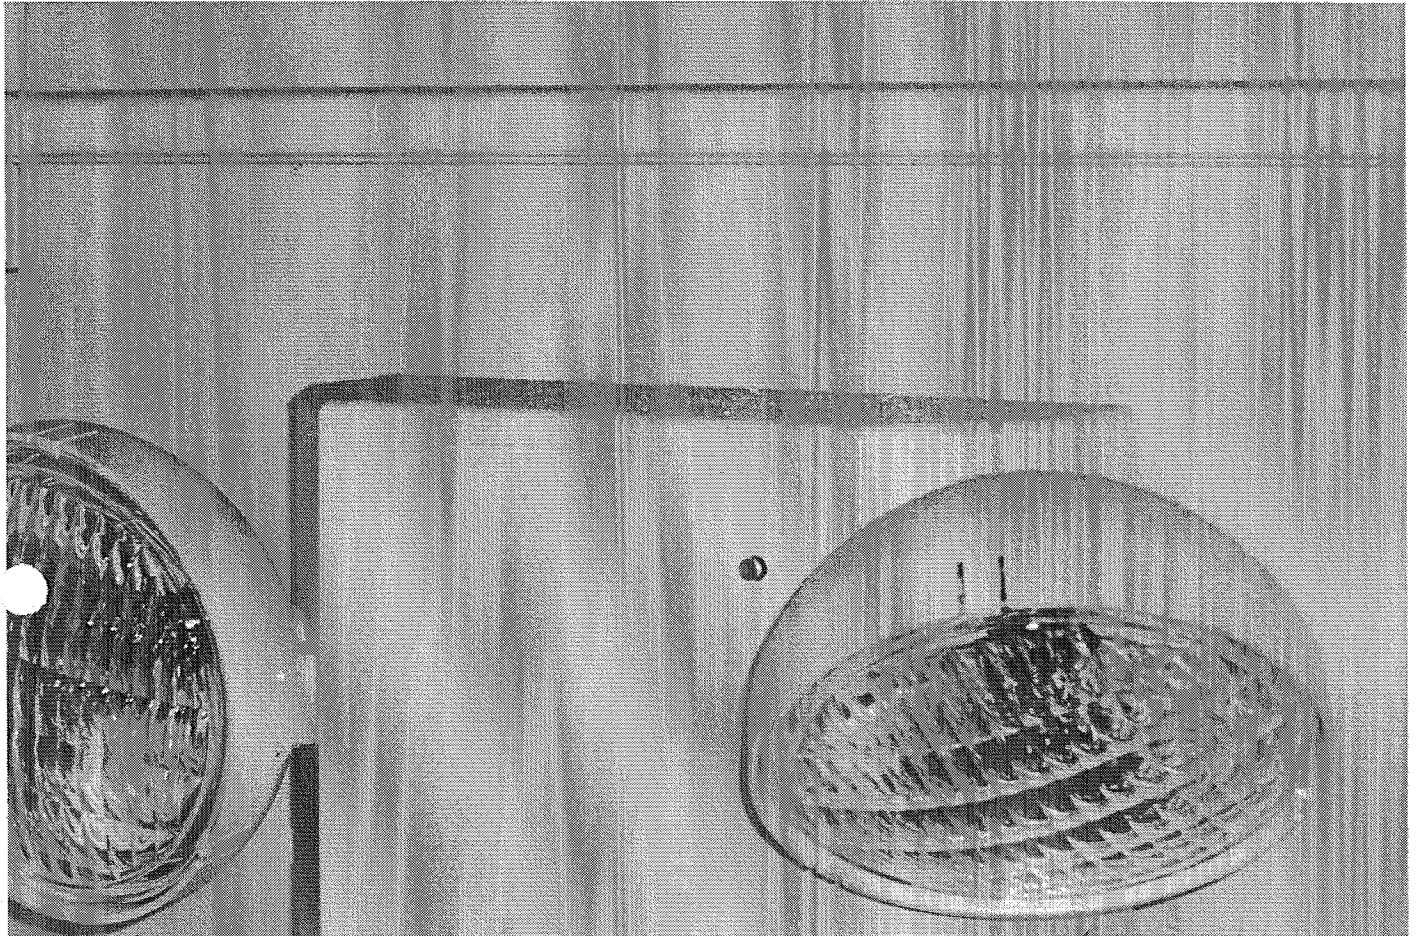
87. 3rd floor, west hall adj to lobby - Location of dust sample #3 -Top of emergency light in west office adj to lobby

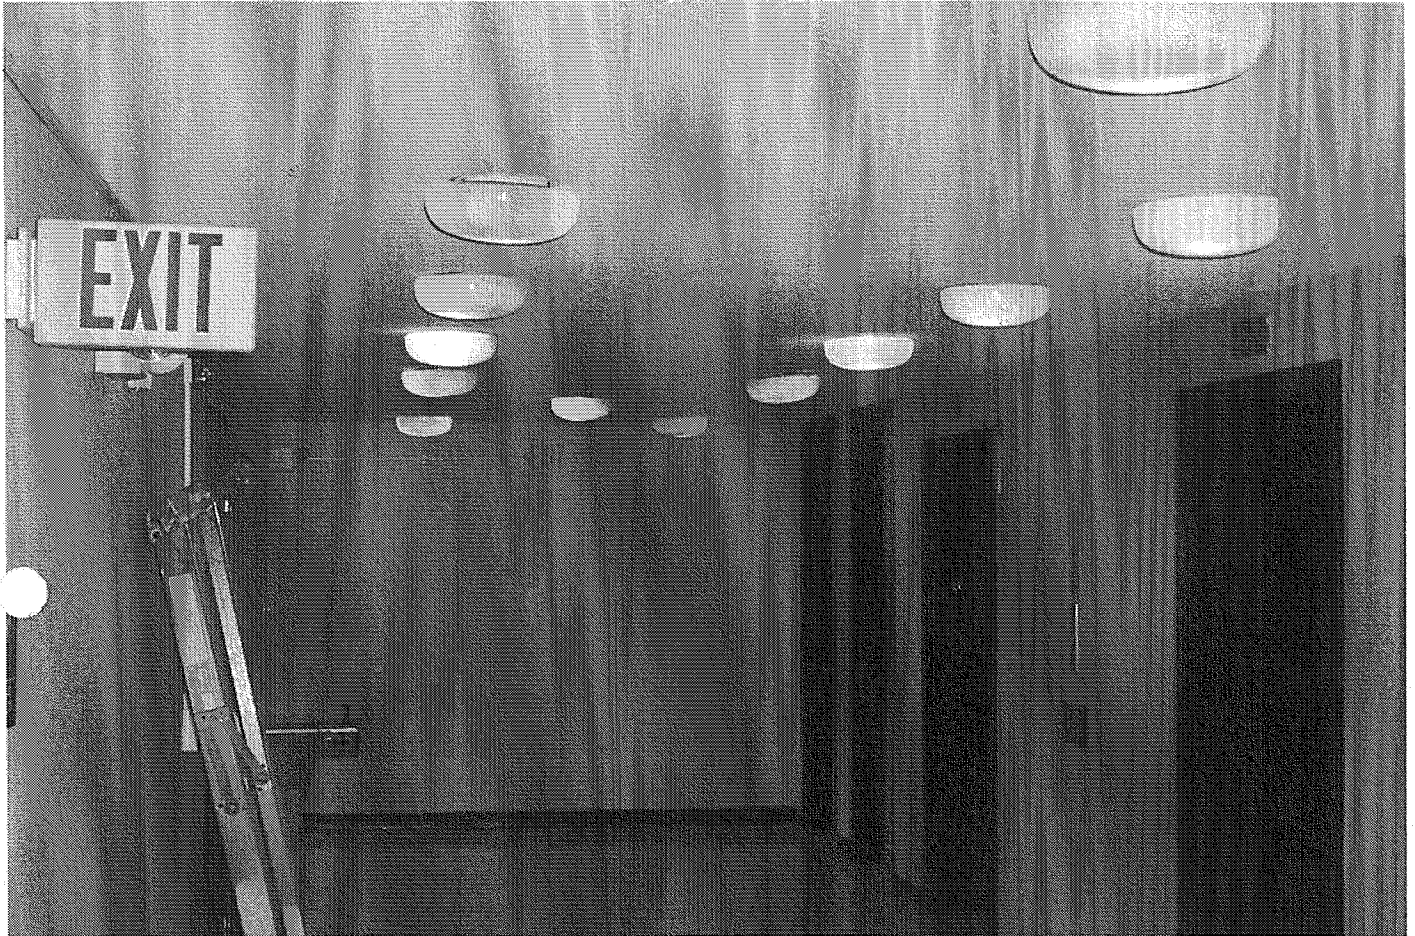
88. B Floor - east hallway - General view of acoustical plaster in hallway

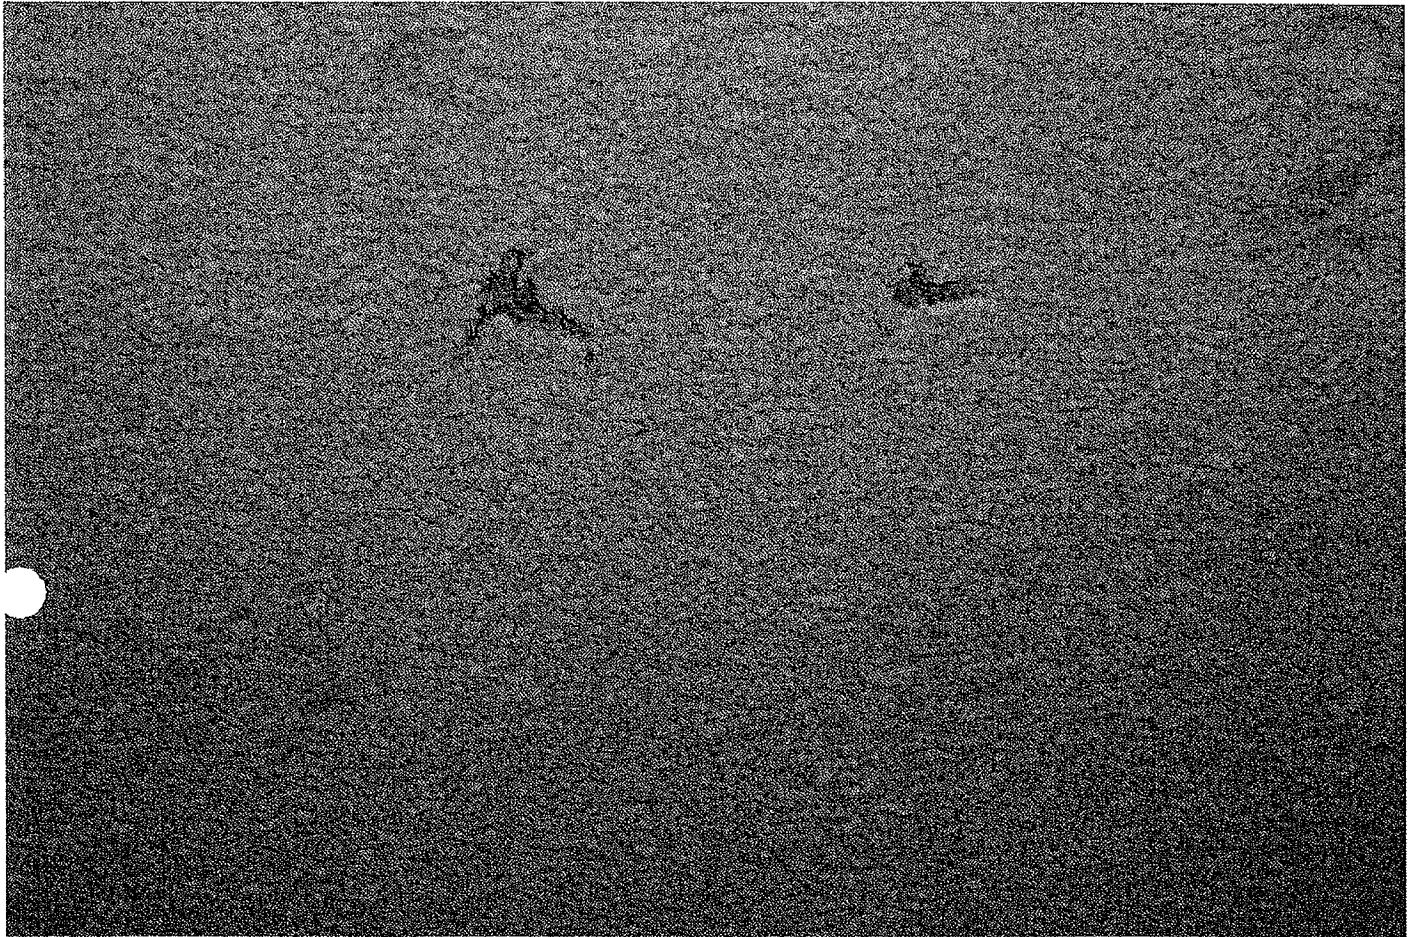
89. B Floor - east hallway - Close-up of damaged acoustical plaster in hallway

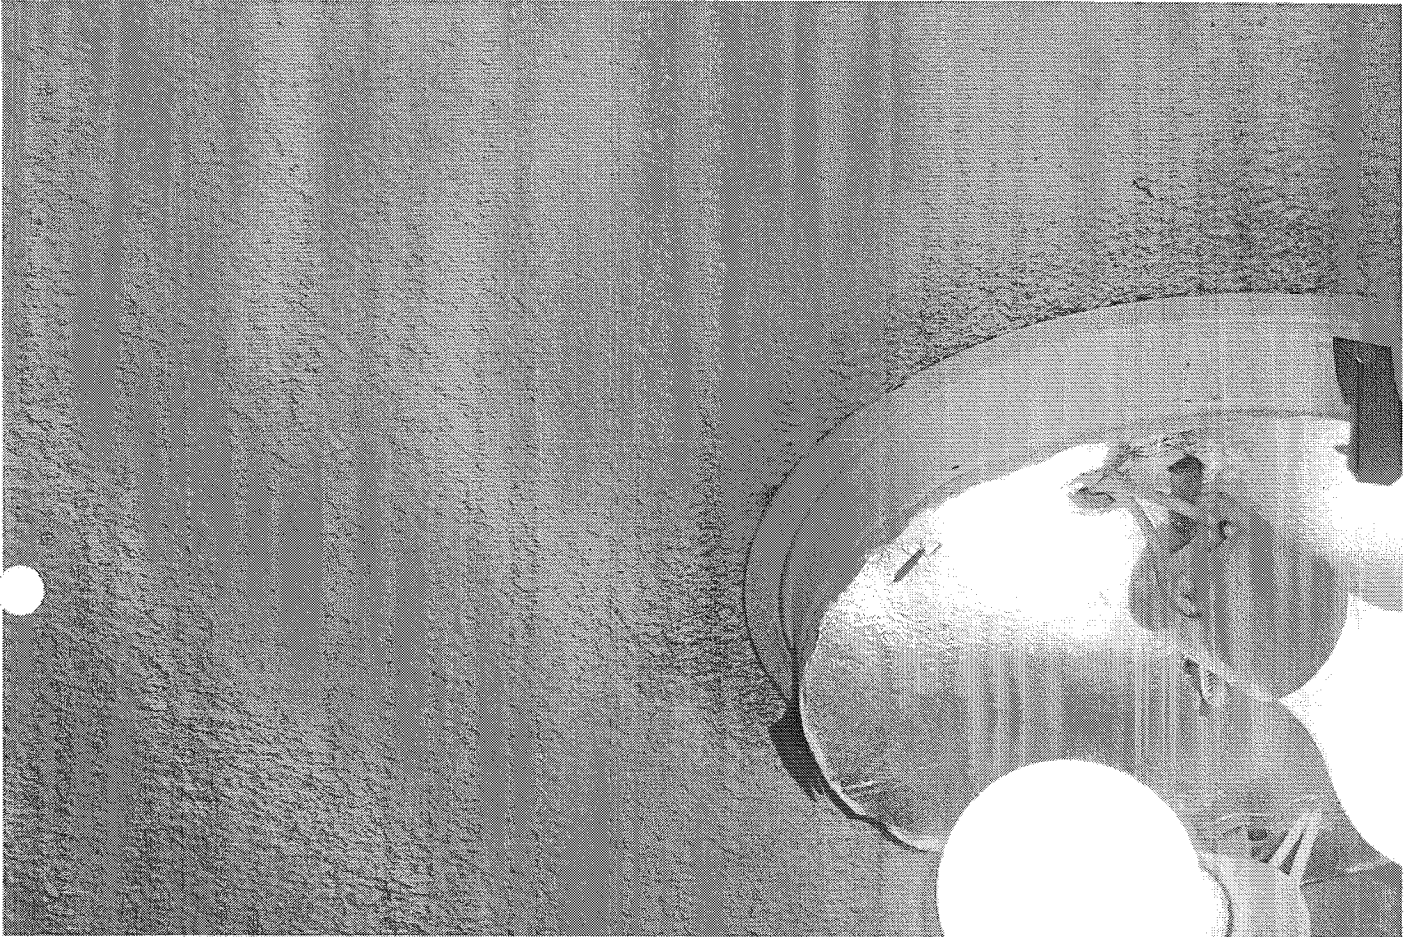
90. B Floor - east hallway - Damaged acoustical plaster at light fixture in hallway
